Mobile Intel[®] Pentium[®] II Processor Specification Update

Release Date: August 2006

Order Number: 243887-054

The Mobile Pentium[®] II processor may contain design defects or errors known as errata which may cause the product to deviate from published specifications. Current characterized errata are documented in this Specification Update.

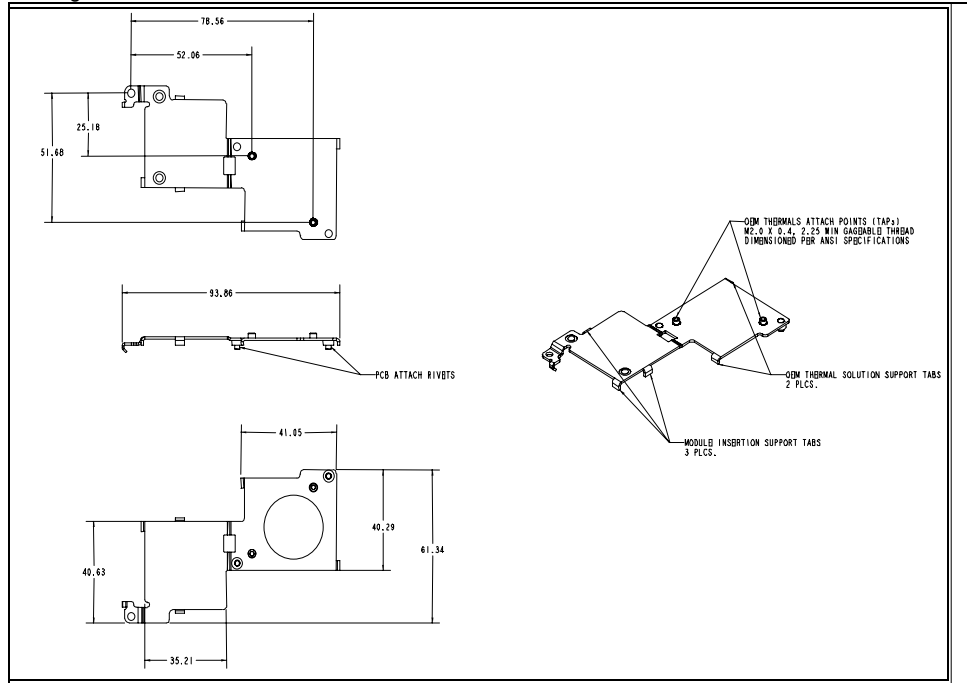
Figure 1. TAP Gageable Thread Clarification

OEM Thermal Attach Points (TAPs) M2.0 x 0.4, 2.25 min gageable thread dimensioned per ANSI specification.

See Figure 1 below for more information.
